Incident Summary Page for the 100 Fires Project

Incident Name: Mack Lake Fire	Incident Date & Time: 05/05/1980 @ 12:45
Incident Location: South of Mio, Michigan on the Huron-Manistee National Forest	Incident Size: 24,000 acres final size Less than 500 acres at the time of the entrapment
Types of resources involved: U.S. Forest Service district personnel	# of Fatalities/injuries: 1 fatality

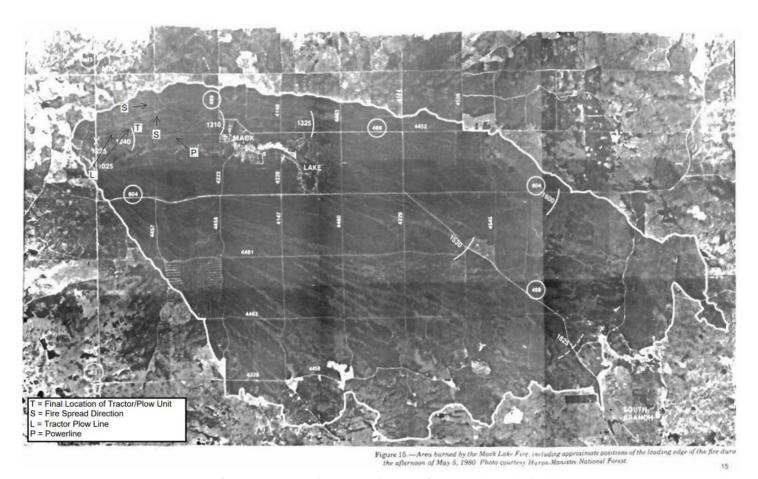
Fire foot print showed evidence of surfacing horizontal roll vortices. These vortices would have caused rapid lateral fire spread to occur. This probably played a role in the difficulty the tractor plow operator and the heavy engine crew encountered while trying to escape the fire on its northern flank.

Orthophoto showing the perimeter of the Mack Lake Fire The light colored unburned stingers of vegetation are a signature of the horizontal roll vortices

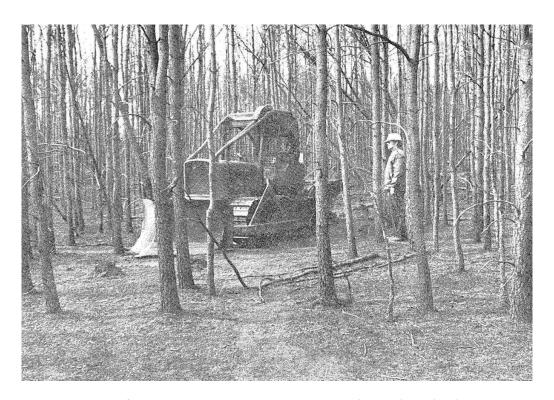
The flame height was forcing both the heavy engine and tractor plow to work some distance from the fire edge. The tractor plow was slower than the heavy engine and was passed by the engine. The tractor plow operator and engine operator did not speak face-to-face and did not have radio communication when this pass was made, but they did make eye contact. From that point on the engine remained in front of the tractor plow. When the fire began to make a push to the north, the heavy engine radioed that they were being forced to disengage from the fire and they moved north to safety. At approximately the same time, the tractor plow operator realized he was in trouble. He raised his plow and began to move north away from the fire. After only 110 feet he abandoned the tractor and ran to the northeast. The fire burned over him 276 feet from his tractor.

Photo of the burned over tractor plow taken during the investigation
