Incident Summary Page for the 100 Fires Project

Incident Name: Sadler Complex	Incident Date & Time: 08/09/1999 @ 15:40
Incident Location: Dixie Creek drainage south of Elko, Nevada	Incident Size: 209,000 acres
Type of resources involved: National Park Service Type 2 hand crew	# of Fatalities/injuries: 6 injuries
Reason this fire was selected for the 100 Fires list: ➤ Fire made a notable impact within the wildland fire service	
Conditions leading up to the event:	
<p>On August 5, 1999, a dry lightning storm passed through northern Nevada igniting numerous wildland fires. The Sadler, Table, Horse, and Pine Fires were combined to form the Sadler Complex south of Elko, Nevada. The Nevada Department of Forestry (NDF) provided an initial attack and set up the initial Incident Command Post (ICP) at a highway rest area about 30 miles south of Carlin, Nevada. As the complexity of the incident increased, a Type 3 Incident Management Team (IMT) was assigned to the fire.</p> <p>On August 6, a Type 2 IMT was assigned to the complex and the ICP and base camp were moved to a location along State Highway 278 about 20 miles south of Carlin in Pine Valley. On August 8, a spike camp was established

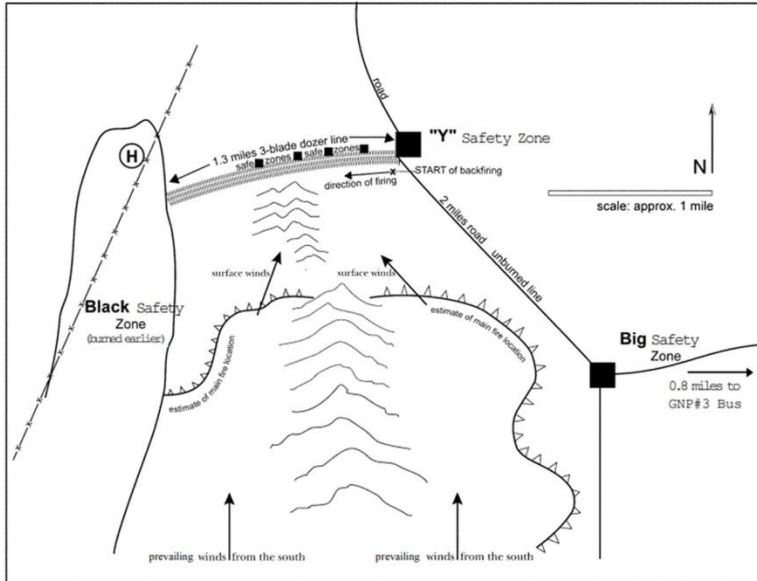
Sadler Entrapment Map 1

Figure 1. August 9, 1999 at around 3:00 p.m. the backfiring operation begins.

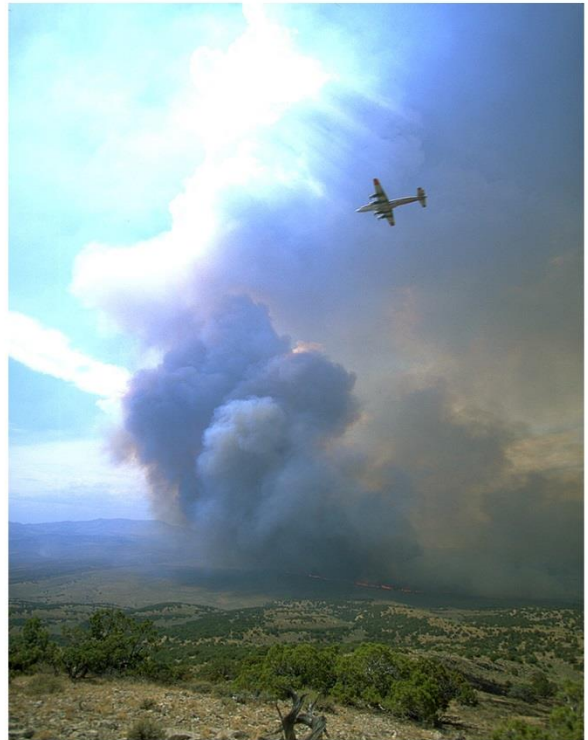
Sadler Fire prior to 15:00.

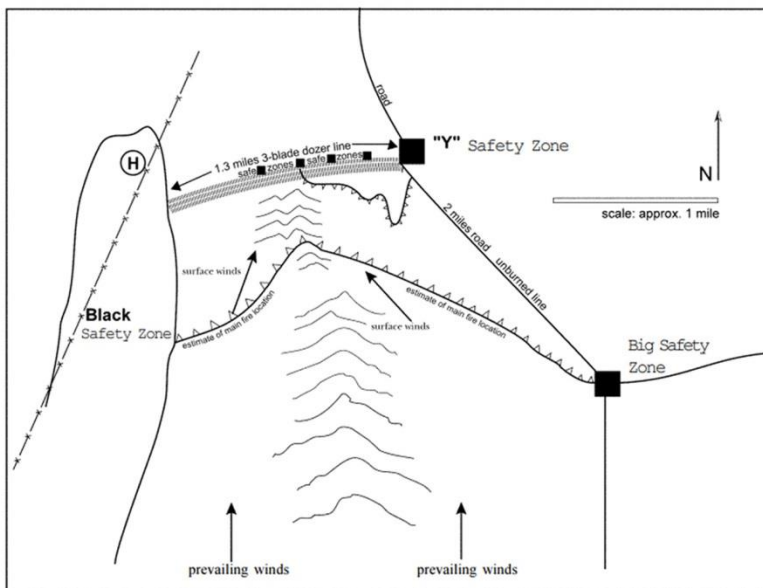
Sadler Entrapment Map 2

Figure 2. Location of the firing squad on August 9, 1999 at around 3:30 p.m.

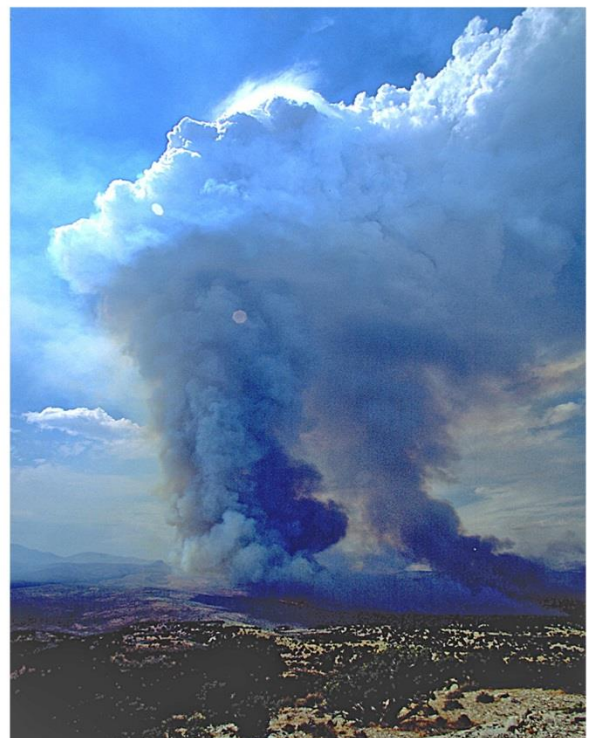
Sadler Fire between 15:10 and 15:25.
Dark smoke to the right is the GNP3 firing operation.

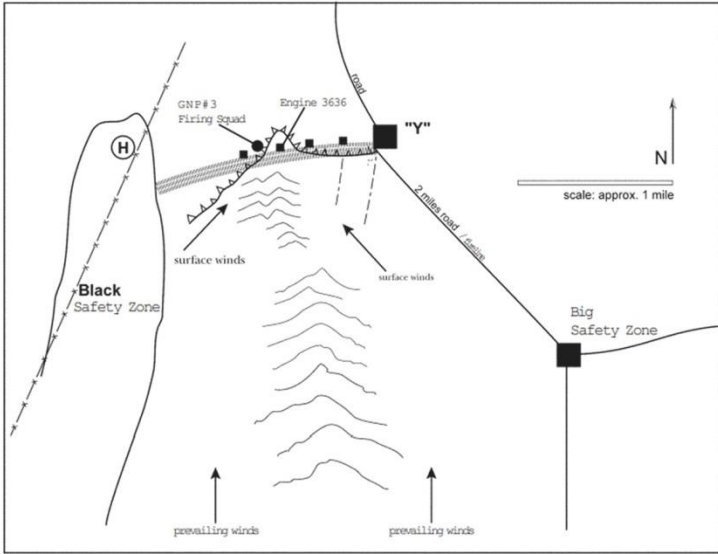
Sadler Entrapment Map 3

15:40 - Branch II and two Dozer Bosses watching the backfire saw the main fire become visible and take off down the hill toward the GNP3 firing squad. They attempted to warn the firing squad but were unable to make radio contact. Shortly after, the main fire became visible to the firing squad as it crested the ridge to the south. It was described as a “*river of fire*” as it made a run at the dozer line and crew with speeds in excess of 300 feet/minute and 15-foot flame lengths.

Figure 3. Location of the firing squad on August 9, 1999 at around 3:40 p.m. when they were overrun by the main fire.

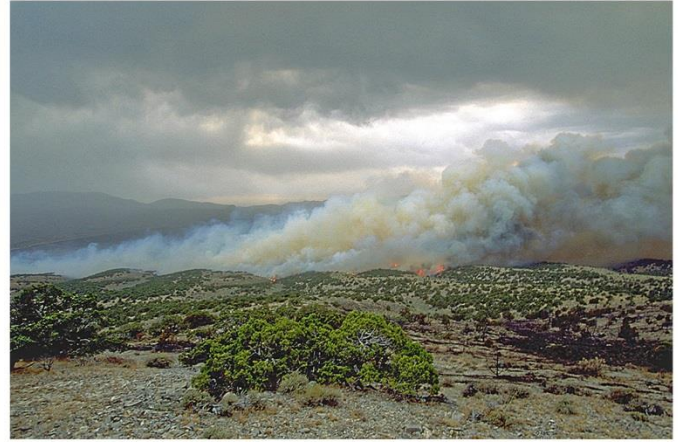
Sadler Fire between 15:40 and 15:50.
About the time GNP3 firing squad is being overrun.

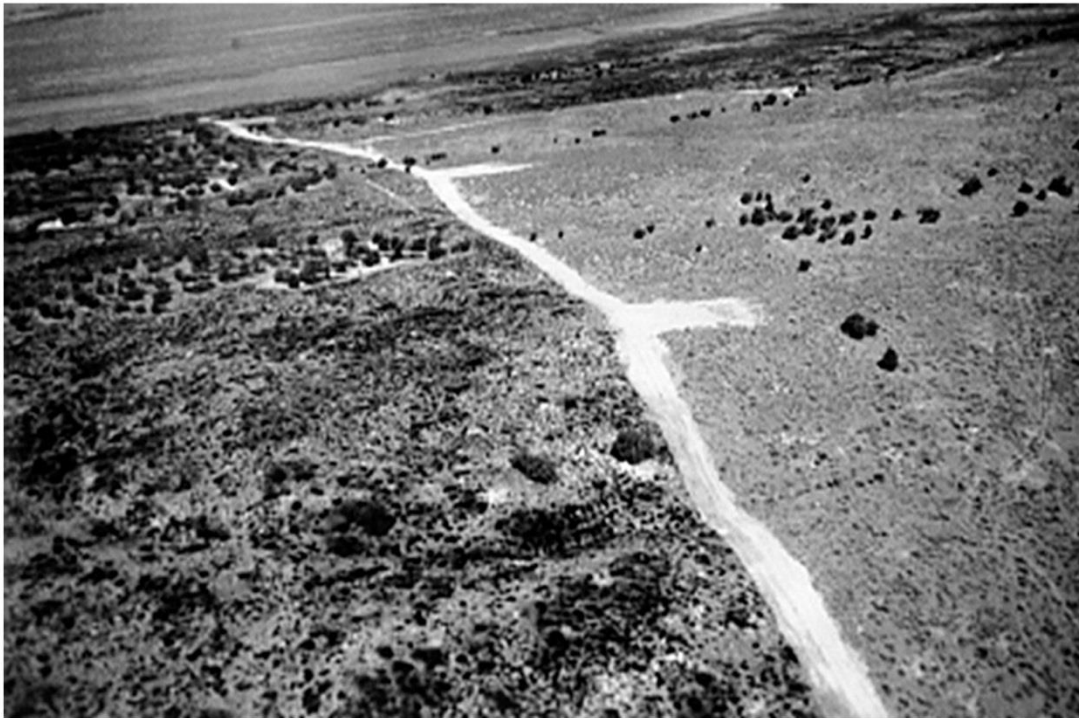
Firing Operations: Firing at the head of a large fire with extreme fire behavior requires careful planning and execution. For the existing conditions on the Sadler Fire in Division Q the pre-identified safety zones along the dozer line were too small and too far apart.

Investigation report photo of dozer line with pre-identified "safety zones."
Fire escape and entrapment site are at the top of the photo.
