## Incident Summary Page for the 100 Fires Project

<b>Incident Name:</b> Sundance Fire	<b>Incident Date &amp; Time:</b> 09/01/1967 @ 16:00
<b>Incident Location:</b> Sundance Mountain, Bonner County, Idaho	<b>Incident Size:</b> 55,910 Acres
<b>Type of resources involved:</b> Heavy equipment and overhead personnel	<b># of Fatalities/injuries:</b> 2 fatalities
<b>Reason this fire was selected for the 100 Fires list:</b> ➤ Fire made a notable impact within the wildland fire service.	
<b>Conditions leading up to the event:</b>	
By mid-August of 1967, the Selkirk Mountains of Northern Idaho were in moderate drought. The last wetting rain of the area was in June, and conditions had steadily become hotter and drier as the months passed. Fire danger was classified “Extreme” when a lightning bust moved through the area. The primary fuel type of these mountains was thick timber with areas of logging slash. During the lightning bust, many fires were ignited, including the Sundance Fire, which started on Sundance Mountain near Sundance Lookout (photo 1).

**This summary page was proudly provided by:**  
Idaho Panhandle Interagency Hotshot Crew

May 2024

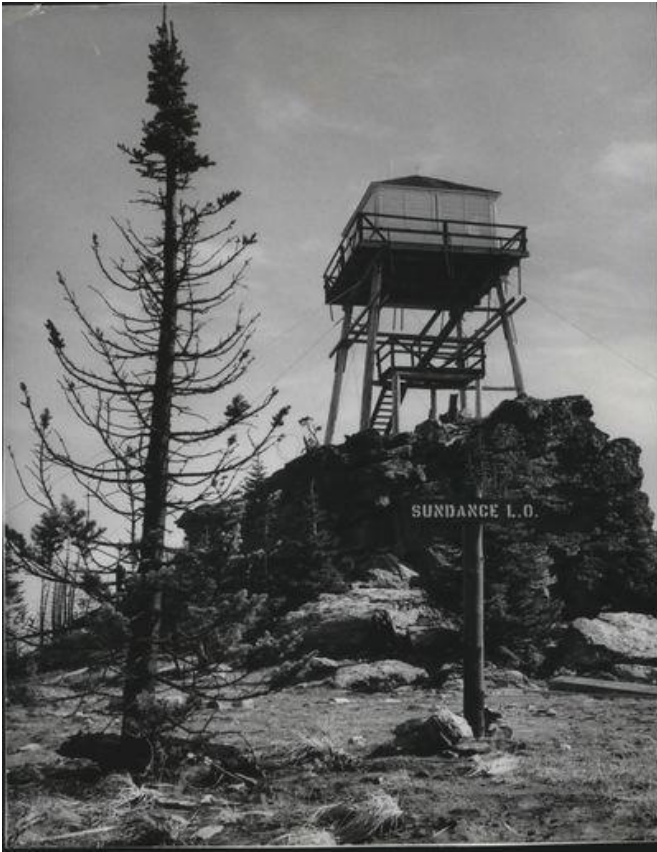
**Sundance Lookout atop Sundance Mountain (6,298 ft) near the initial strike location. The trees are nearly completely consumed with only the tops still housing needles. (Landers, 2017)**

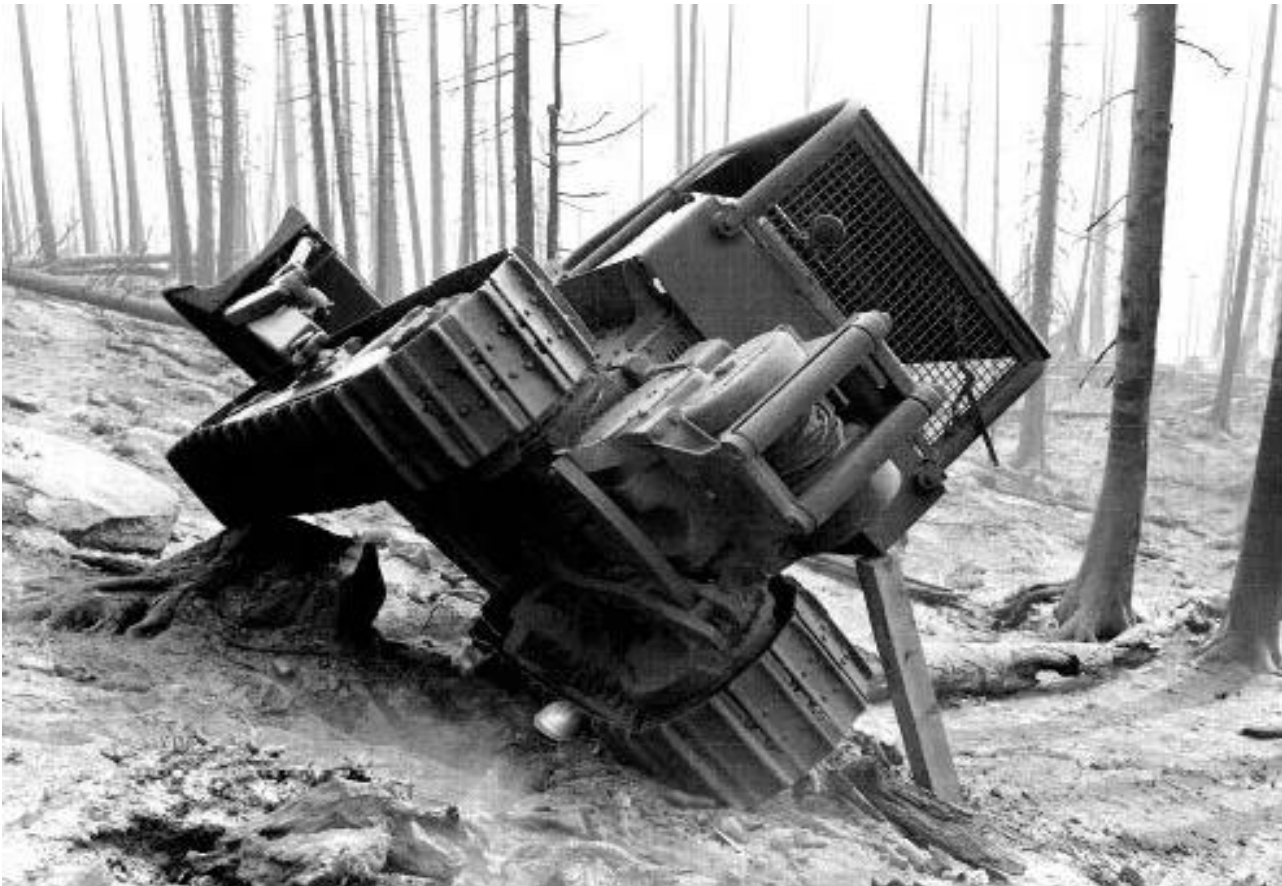
- The safety zone for the Dozer Operator and Sector Boss, was almost four miles away and 3000 ft of elevation gain. Their plan was to work up-canyon towards the lake. However, the fire burned over their position while they were still a quarter mile away from their safety zone.

**The dozer after the burn over. (Peterson, 2023)**

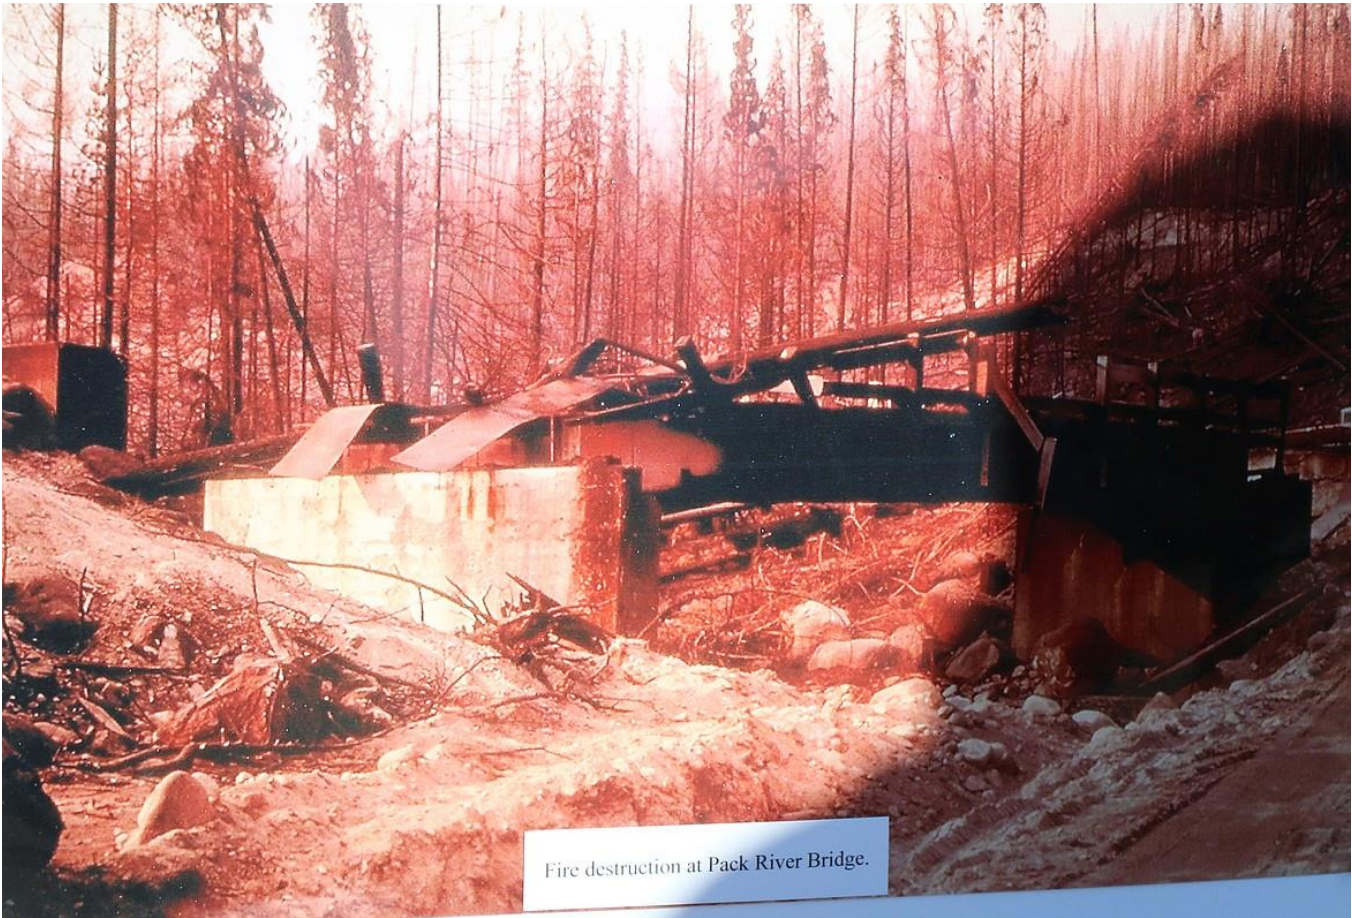
At 11:00 hours, a Dozer Operator and Sector Boss began work moving up the Pack River drainage toward their safety zone on the eastern part of the Selkirk Divide. The safety zone was located at Fault Lake; nearly 4 miles up drainage and 3000 vertical feet above them. By 13:00, only 2 hours into their work shift, strong southwest winds took hold of the fire as it raced eastward, up Soldier Drainage, to the top of the Selkirk Divide. Throughout the afternoon, the fire made large downhill runs on the eastern side of the divide as winds ranged from 30 to 50 mph.	
Both the Sector Boss and Dozer Operator were overtaken in the Pack River drainage at approximately 16:00 where they hid underneath the dozer to shield them from the flames pushing down the river drainage (photo 2). Sadly, both men were found dead on site. Their names were Luther Rodarte and Lee Collins.	
The Sundance Fire moved on to burn ~10 million board feet of lumber spanning 55,910 acres. The fire was so hot in some drainages that it created its own winds strong enough to snap large trees and spot 10 miles ahead of itself. In the Pack River Valley, temperatures reached 1200 °F which caused the steel of the Pack River Bridge to warp (photo 3).

**The fire damaged Pack River Bridge. Anderson infers that the fire reached 1200°F for the steel to warp under its own weight. (Caroline Lobsinger, Bonner County Daily Bee, 2017)**
